COUNTRY: UNIDENTIFIED 4 MAY 1966
 SUBJECT: Exploitation of Metallic Fragment from Unidentified Flying Object
 DATE DISR: 4 MAY 66
 NO. PAGES: 2
 REFERENCES: [REDACTED]

On file in CIA Library is an exploitation report on a metallic fragment approximately 2"x2"x1", recovered near Kerekene, Republic of the Congo. The fragment was recovered by ground search after a UFO fell to earth in the area. The report concludes that the fragment was originally part of an electrical component and was constructed of 0.010-inch thick silicon-steel laminate.

FRAGMENT, METAL, RECOVERED IN THE REPUBLIC OF THE CONGO,
GARRIS BELIEVED TO BE AN UNIDENTIFIED FLYING OBJECT
(COUNTRY UNIDENTIFIED) (U)
MCN-25500

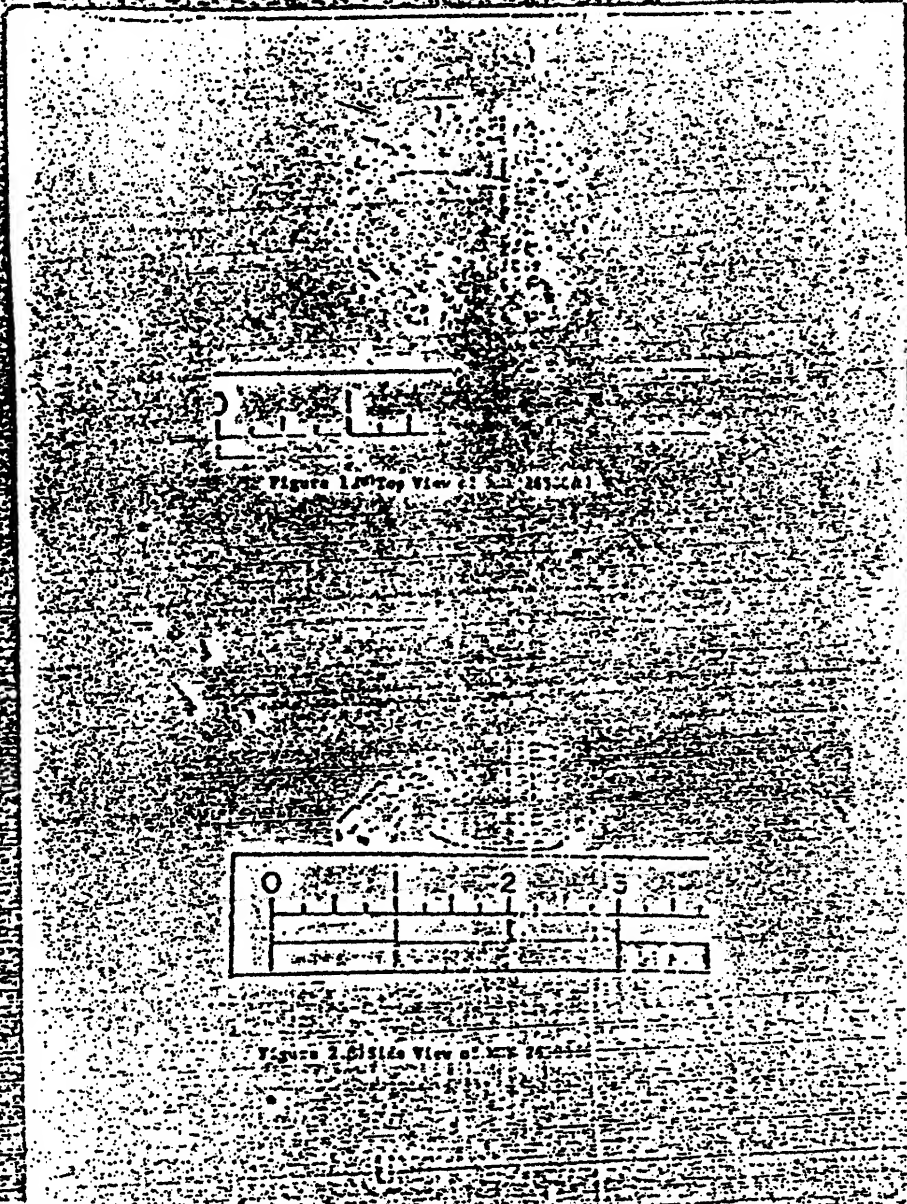
FIGURE 1

2. (C) Details concerning the exact location and characteristics of impact are unknown. However, the appearance of the fragment indicated exposure to high temperatures prior to impact. The surface of the specimen had little or no effect on its final condition or appearance. The fragment weighed 4.41g and an immediate density of approximately iron and measured 2.25 x 1.75 x 1.0 inches. The top and side views of the specimen were rounded and appeared to have been shaped by heating and melting. This is illustrated in Figures 1 and 2. The V-shaped groove, visible in Figure 1, is the outline of an insert of steel that differs slightly from the rest of the specimen. Figure 3 shows the side view of the end shown in Figure 1.

Figure 1. Top View of the Device

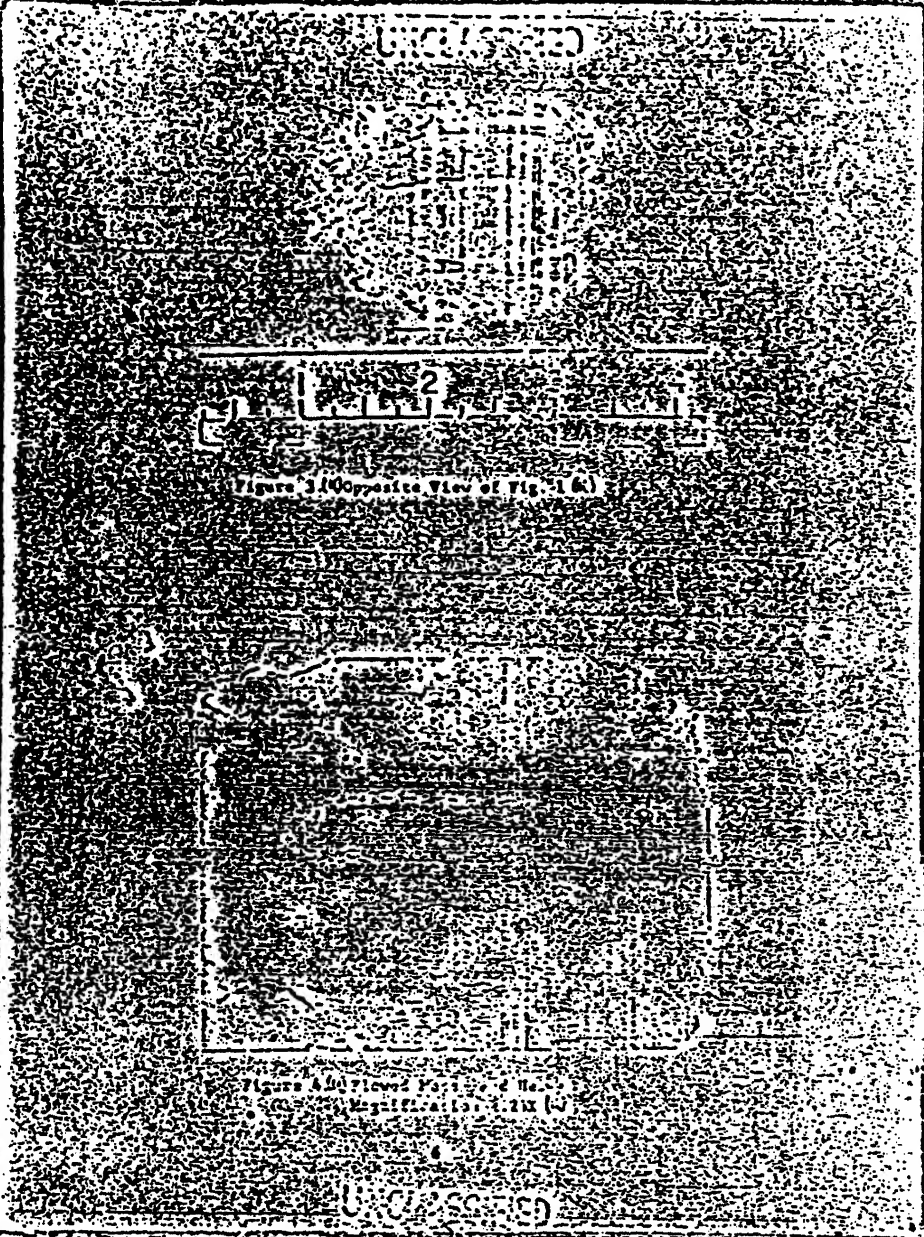
Figure 1 Opposite View of Fig. 1 (a)

Figure 2 Opposite View of Fig. 1 (b)

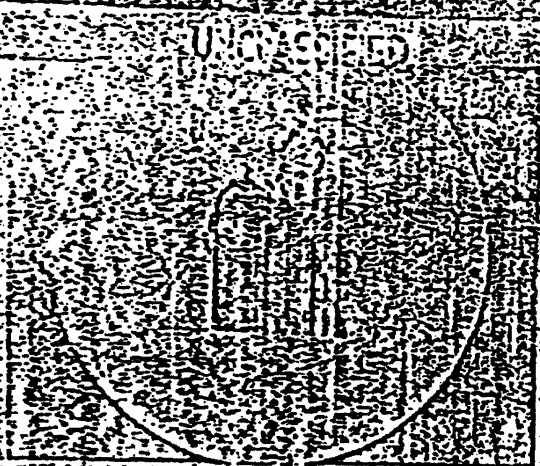
7. (C) The recovered specimen was a steel core and had a country closely approximating that of the fragment. The metal on heavy oxide was found to have been exposed to temperatures in excess of 2800° F. While there are no indications of impact, the flawed metal, as shown in Figures 4 and 7, would substantiate the conclusion that the item was moving at a high velocity when it was hot.

10. (C) The lamination or sticking of individual laminates is clearly illustrated in Figure 6. The space between laminates on the fin at the top of the photograph is due to the melting and flowing of the copper plating during the high temperature exposure of the specimen. Some of the copper has been removed from the fin at the bottom of the photograph. A representative cross-section of this area is shown in Figures 7 and 8.

Figure 7. Micrograph Cross-section of
 Laminated Area
 Magnification 7,71X 6X

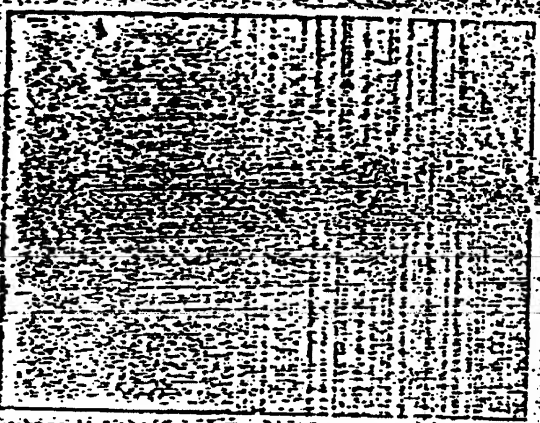
Figure 8. Micrograph Cross-section of
 Laminated Area
 Magnification 10X 6X

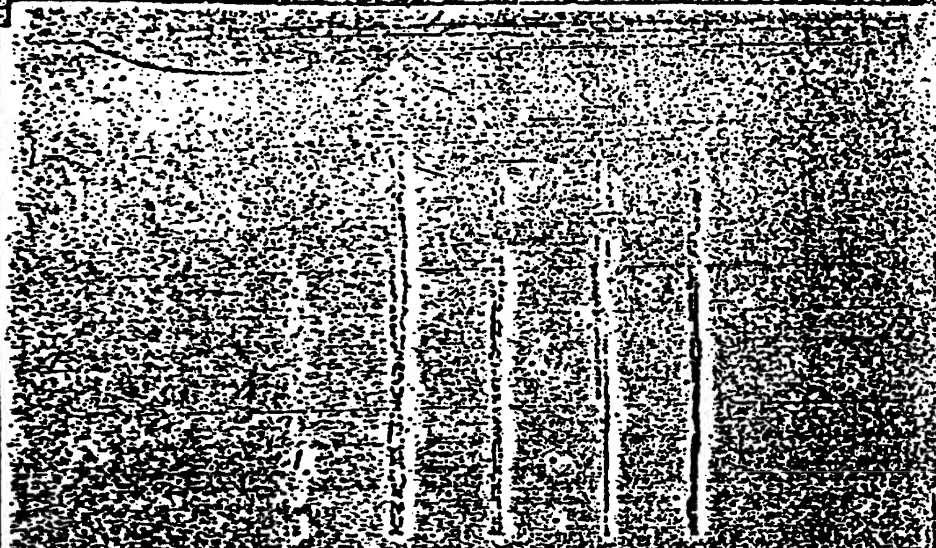
11. (C) Another result of intense heating was the enlarged grain size of the steel laminates' microstructure. The microstructure of the laminates shown in Figures 9 and 10 illustrates grain sizes that are comparable to Company 2 of ASTM Grain Size Standards. The large grain size indicates that the steel was heated to a temperature above the recrystallization temperature.

12. (C) The light material between the laminations in Figure 9 is plated copper that melted and flowed between the laminations when the entire specimen was hot. A photomicrograph of this is shown in Figure 11.

Figure 9 (a) Source Picture
of the
Regulation of
(C. Nical Etch)
